Coal Combustion Waste Impoundment Round 5 - Dam Assessment Report

Plant Wansley (Site # 006)
Ash Pond Separation Dike

Georgia Power
Carrolton, Georgia

Dewberry & Davis, LLC
Fairfax, Virginia

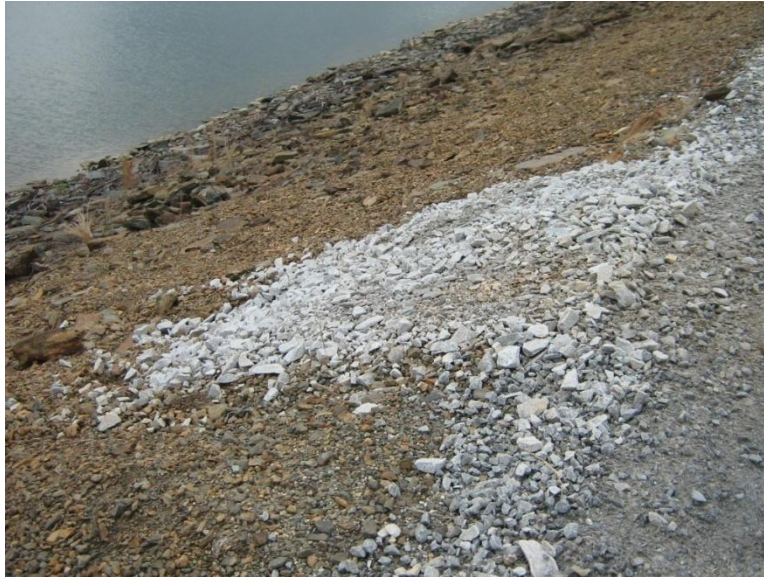
The downstream slope is mostly lined with rip rap and stone. Scarps, sloughs, depressions, bulging or other indications of slope instability or signs of erosion were not observed. Gravel had been placed at a few locations along the embankment as some regular maintenance. The toe of this slope is below the normal pool of the cooling water pond; therefore, visual assessment of seepage could not be performed.

Figure 5.2.3b: Gravel placed along downstream embankment which appeared to be routine maintenance

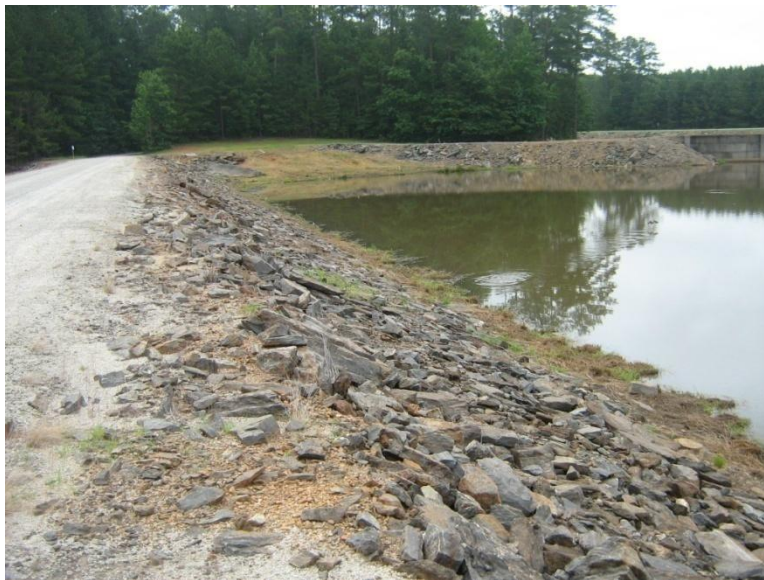
Figure 5.2.3c: Crest and Downstream Slope of ash pond's western dike.

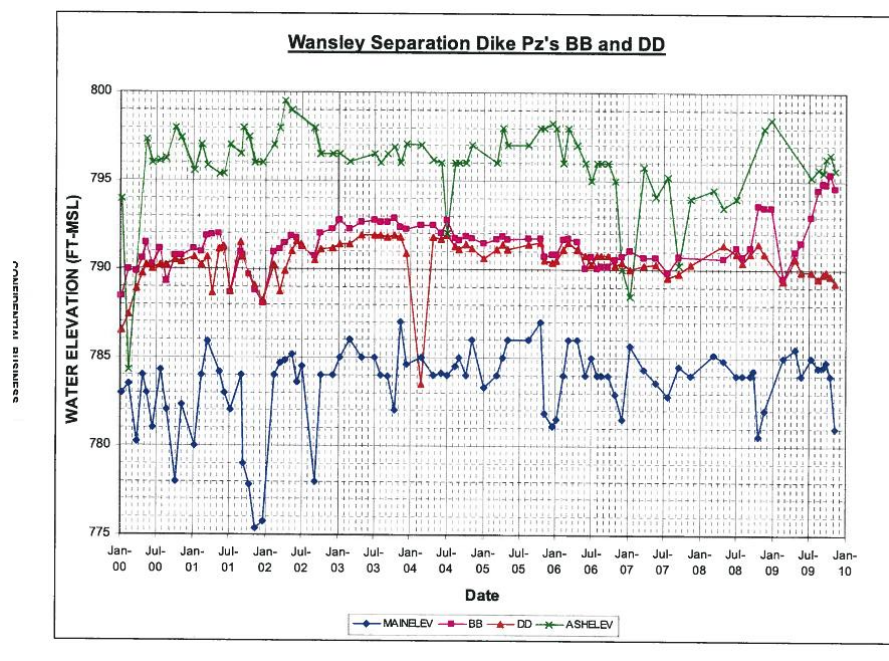
Figure 7.1.3a: Historic Piezometer Readings

The locations of the piezometers are depicted in Figure 9.2.1, within the Instrumentation Plan Section. (See Appendix A Doc 1 through 5 for inspection reports showing historical piezometer data). Piezometer BB was damaged in 2008 and Georgia Power stated it was recently repaired.

The increased elevated readings of piezometer BB starting in 2008 were potentially caused from measurements being made from different reference points when the top of the pipe was broken off.

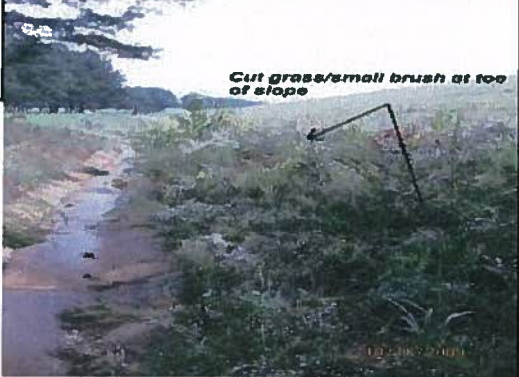
| Photo No. | Description | |
|---|---|--|
| 3 | Storage Pond - East Dike - Cut grass/brush down along toe of dike. | |

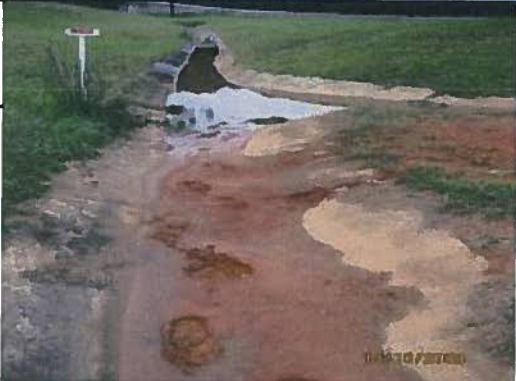
| Photo No. | Description | |
|---|---|--|
| 5 | Storage Pond - East Dike - Remove mud/debris from drainage ditches, along east dike. | |

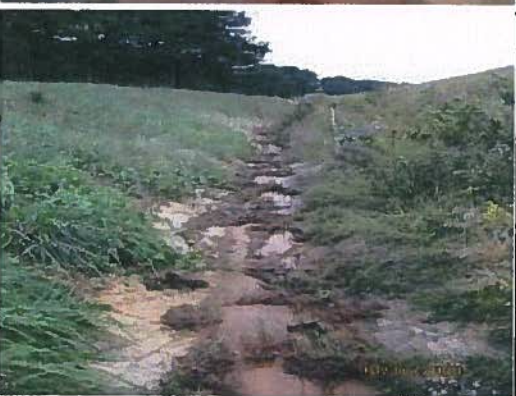
| Photo No. | Description | |
|---|---|--|
| 6 | Storage Pond - East Dike -Toe Ditch - Remove overgrowth from drainage ditch | |

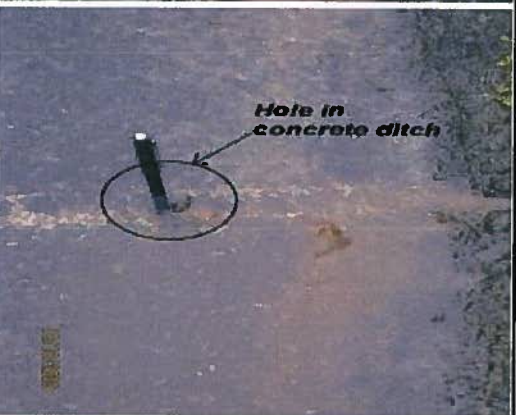
| Photo No. | Description | |
|---|---|--|
| 7 | Storage Pond - East Dike -Toe Ditch - Localized holes in concrete ditch need to be grouted to prevent water flow beneath concrete and potential ground loss | |

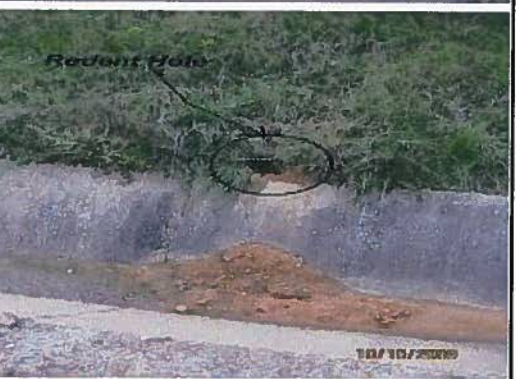
| Photo No. | Description | |
|---|---|--|
| 8 | Storage Pond- Southeast Dike - Rodent holes on slope need to be filled in. | |

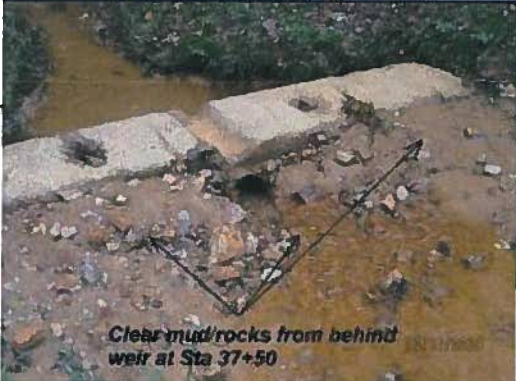
| Photo No. | Description | |
|---|---|--|
| 9 | Storage Pond - Southeast Dike - Lower Slope - Sta 37+50. Clear mud/rocks from behind weir. | |

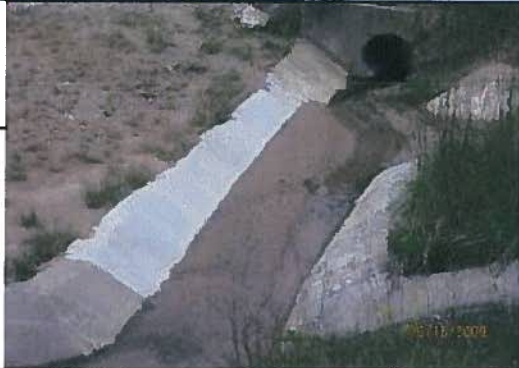
| Photo No. | Description | |
|---|---|--|
| 13 | Storage Pond- Southeast Dike - Lower Slope - Toe Ditch - Mud needs to be removed from ditches. | |

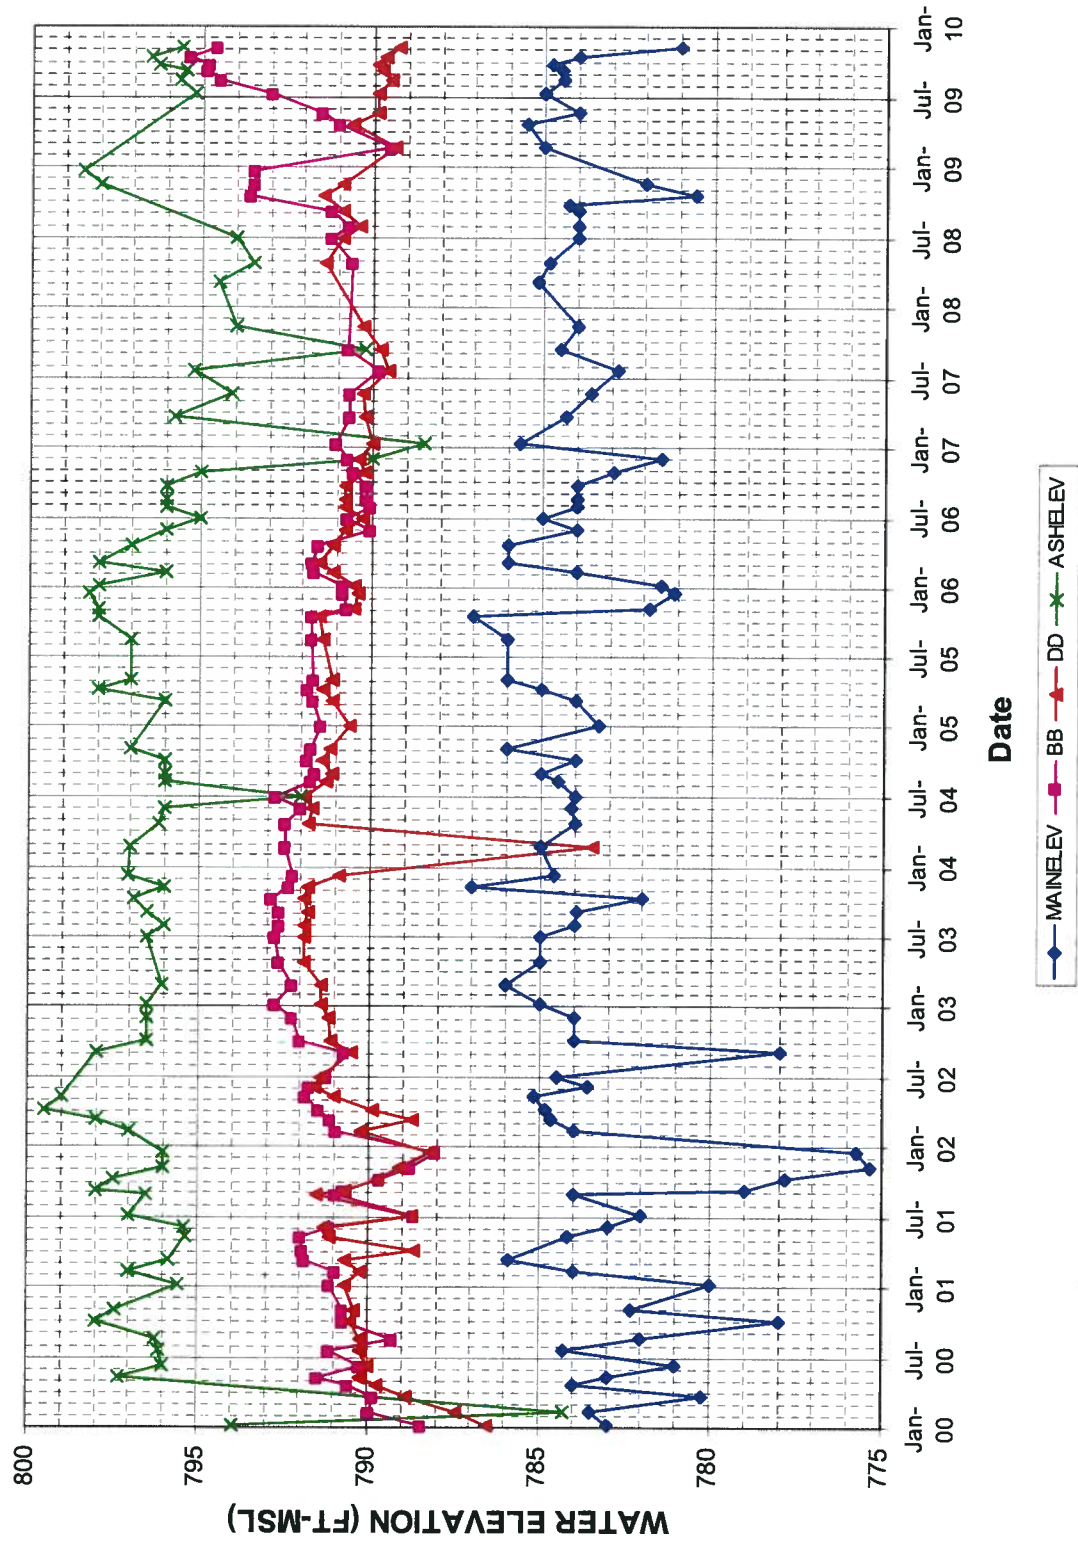
Wansley Separation Dike Pz's BB and DD

- The piezometers on the separation dike are generally registering within their historical ranges. Piezometer BB is registering an elevated water level and has generally followed the change in the ash pond elevation. This piezometer was repaired after being damaged in 2008.

- It was noticed the piezometer BB had been broken off and buried during the recent gypsum storage facility construction activities. Water levels in the piezometer appear to be higher, but this may be caused by inspectors using a different reference point to measure the water levels with the pipe being broken off. Plant personnel are inspecting and will advise Hydro Services.
- Current Recommendations: Cracks in concrete lined ditches should be cleaned out and caulked. **Pending completion - open.**
- Status of Previous Recommendations: Upstream and Downstream slopes - Localized erosion rills/gullies need to be repaired to mitigate further erosion. **Fixed – closed.**
- Status of Previous Recommendations: Runoff erosion at crest of upstream slope repaired. **Closed.**

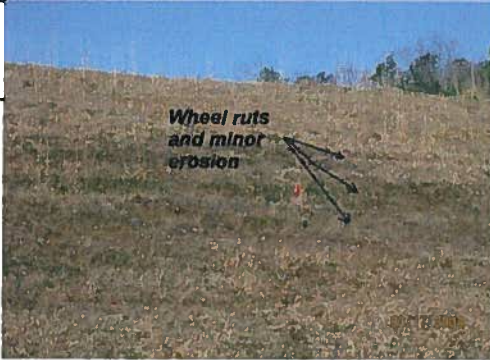
| Photo No. | Description | |
|---|--|--|
| 1 | Storage Pond - East Dike - Localized wheel ruts/erosion need to be repaired on slope. | <p>Wheel ruts and minor erosion</p> |

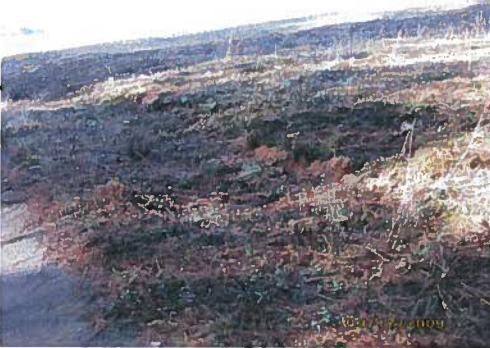
| Photo No. | Description | |
|---|--|--|
| 2 | Storage Pond - East Dike - Localized erosion and bare areas on dike slope and adjacent to toe ditch. Re-establish grass cover. | |

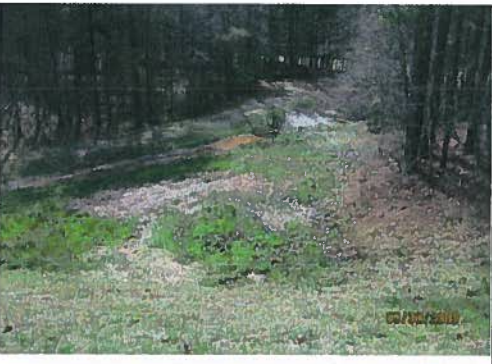
| Photo No. | Description | |
|---|---|--|
| 7 | Storage Pond - East Dike - Lower Slope - Sta 37+50. Condition unchanged from previous 4th Qtr visit. | |

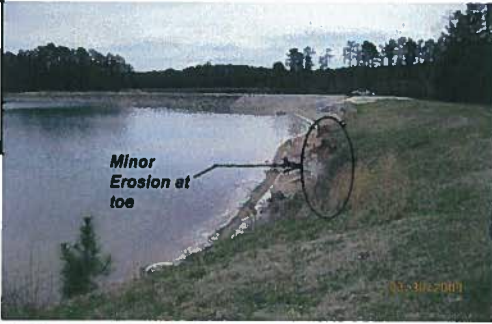
| Photo No. | Description | |
|---|---|--|
| 10 | Ash Pond- Emergency Overflow - Upstream - Minor erosion at toe of slope at waterline. Should be monitored for further deterioration that will require repair | |

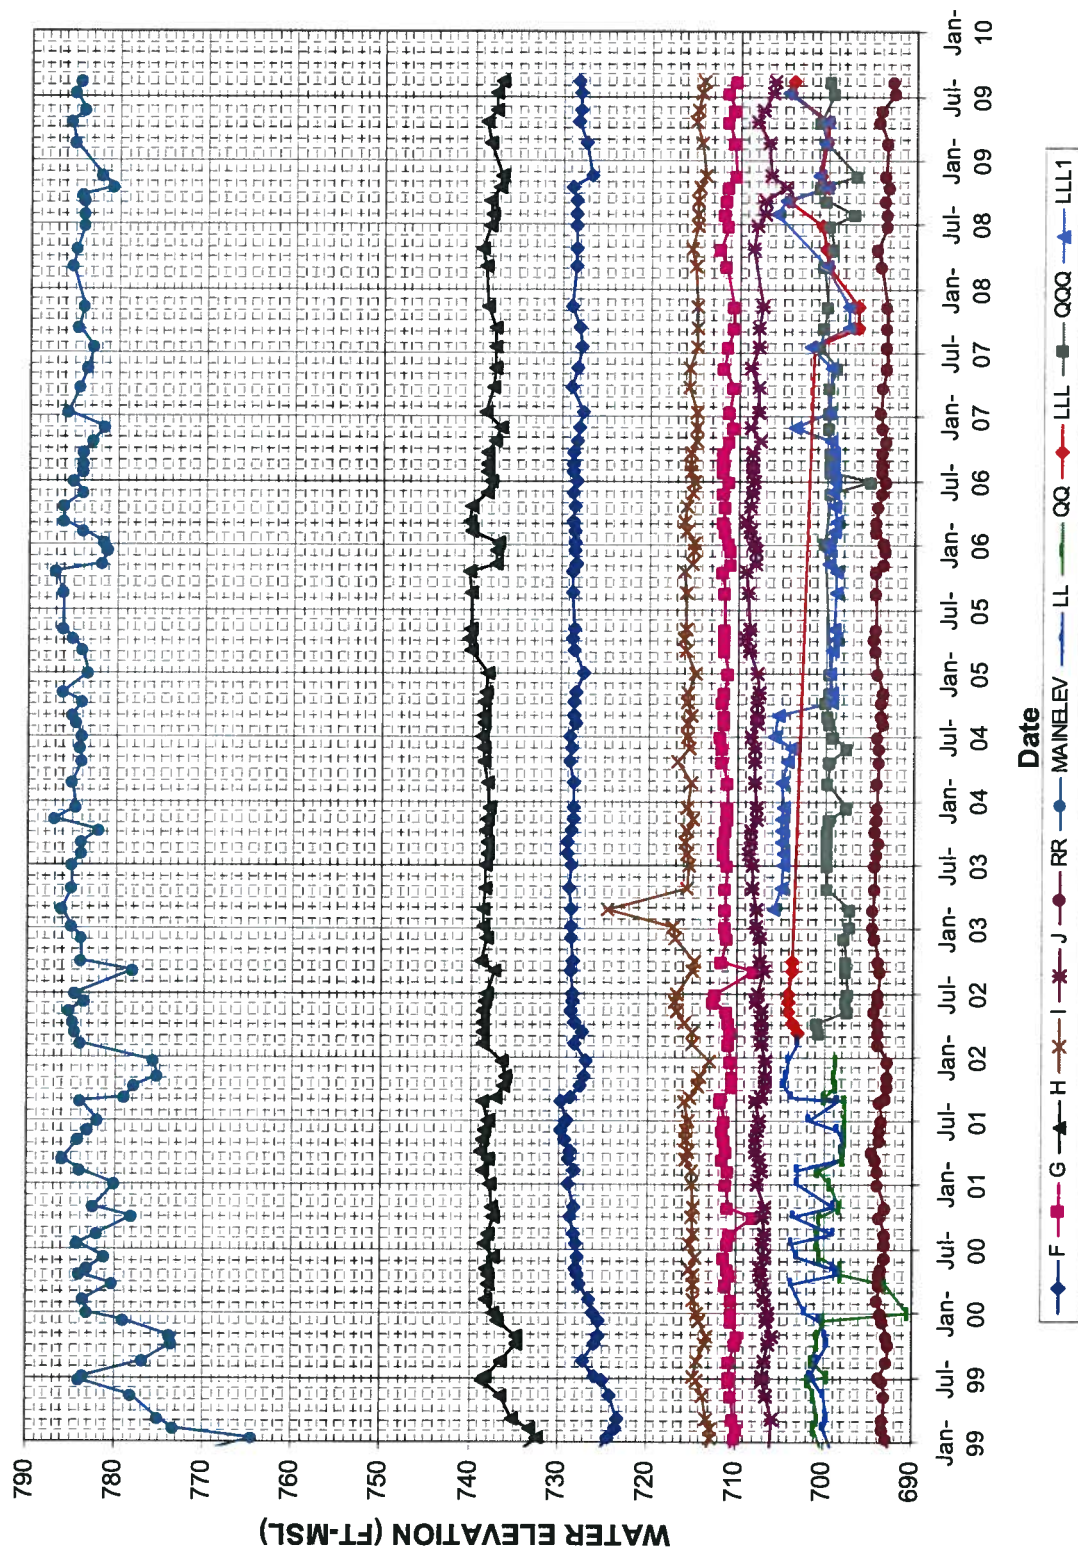
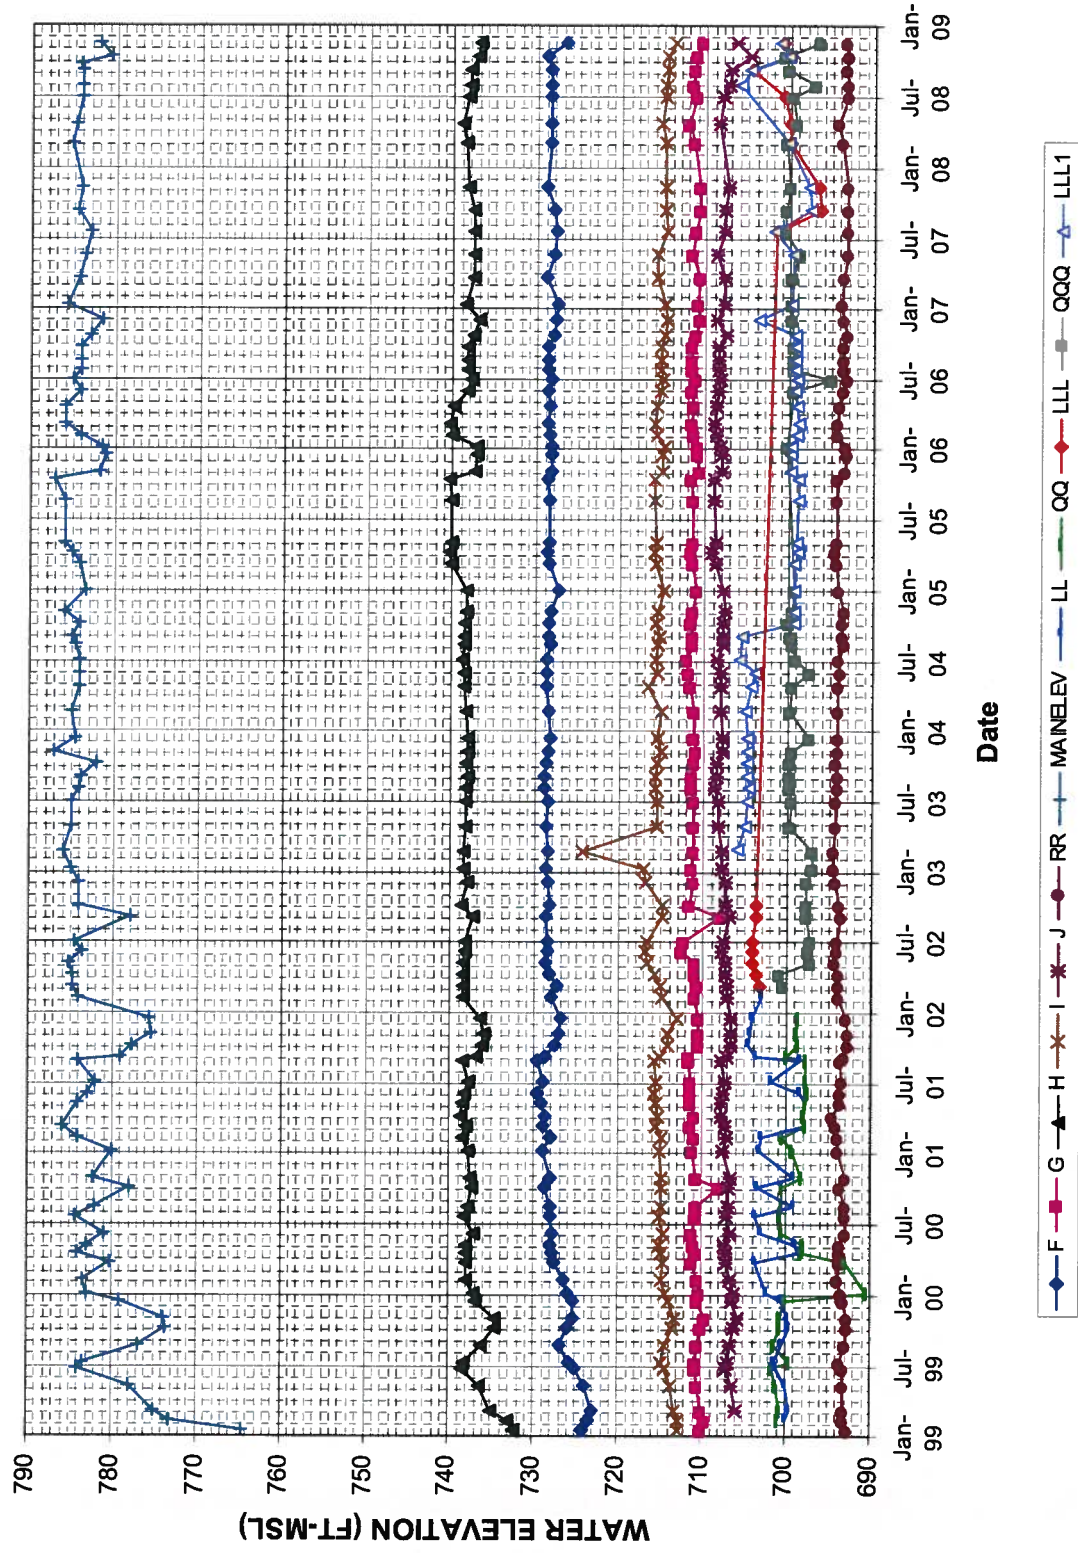
Wansley Storage Pond Pz's at Sta. 58+00

Sta 58+00: The level at piezometer LLL has dropped to more a more consistent historic level, which may be in part related to the decrease in pond level. Repair of a leaking valve, as noted in the attached quarterly report, is required for piezometer LLL.

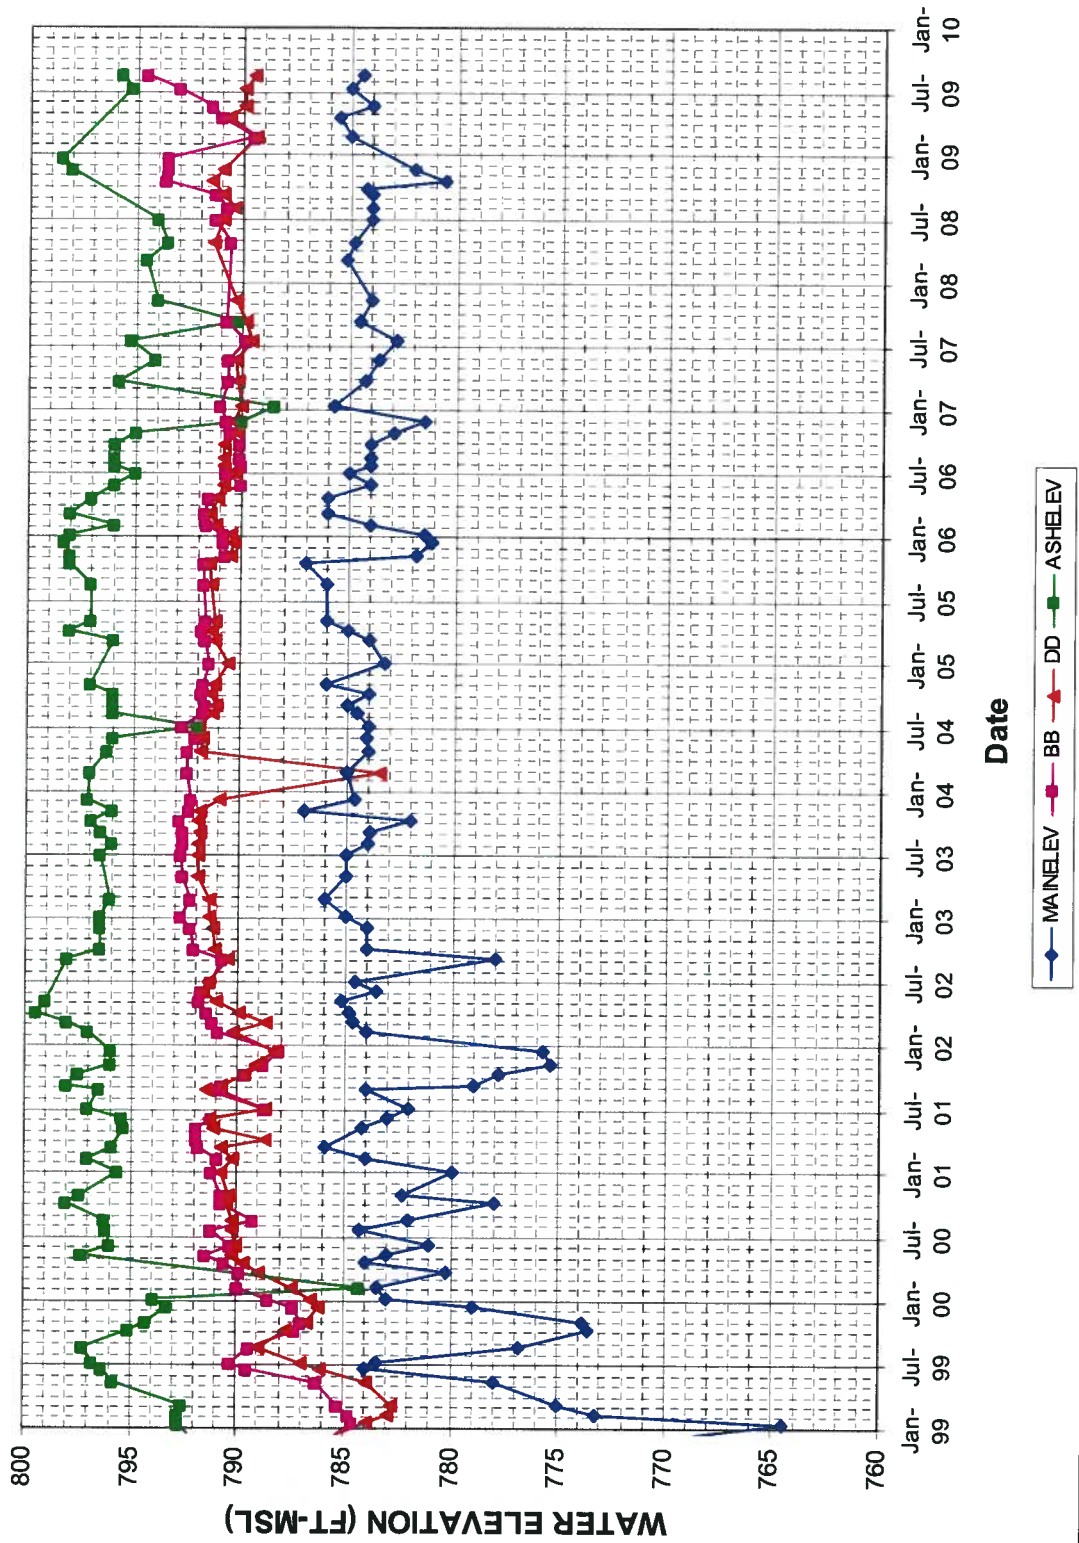
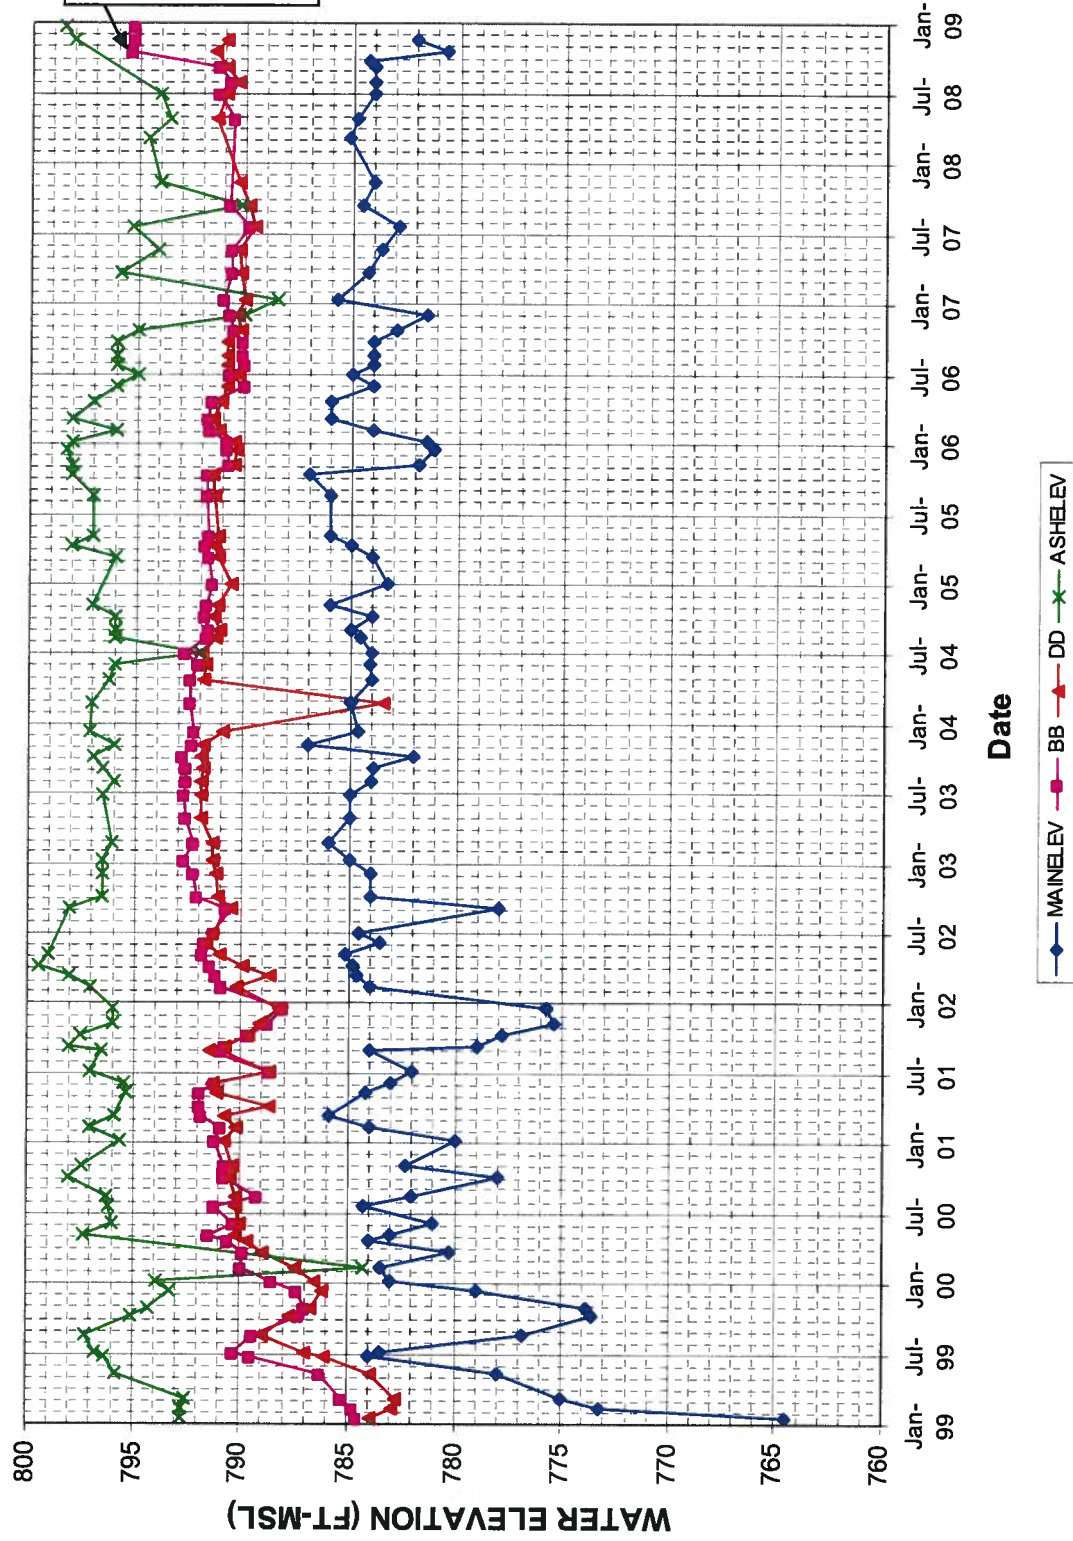
Wansley Separation Dike Pz's BB and DD

These piezometers are generally registering in their historic ranges. Piezometer BB has recently exhibited an elevated water level. In discussions with plant personnel, we understand that piezometer BB was covered over during construction of the gypsum ponds this year. The piezometer pipe appears to have been broken off at some point when it was uncovered. This may explain the “apparent” elevated water level, particularly if the measurements have been made from a lower reference elevation than

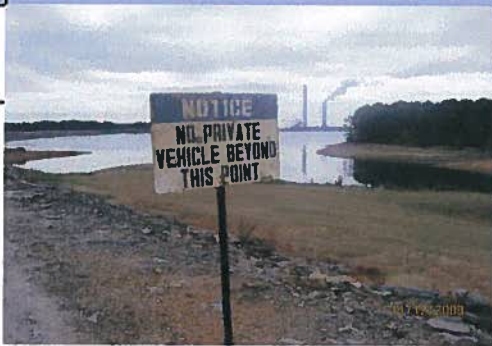
| I - Storage Pond - North Dike - (Road to Recreational Area) | | Storage Pond Elev. 778.1' |
|--|---|---|
| a. Condition | Gravel surfaced - No distress or potholes in road surface observed. Sign has been re-mounted on post | 1 |

| Photo No. | Description | |
|---|---|--|
| 1 | Storage Pond - N Dike - Near Rec. Center Entrance - Notice sign re-mounted on post | |

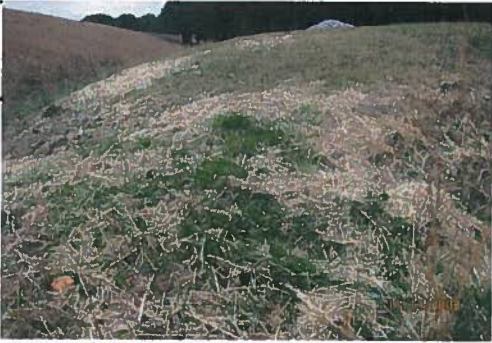
| Photo No. | Description | |
|---|---|--|
| 2 | Storage Pond - East Dike - Localized areas have been re-seeded to re-establish grass on former bare areas | |

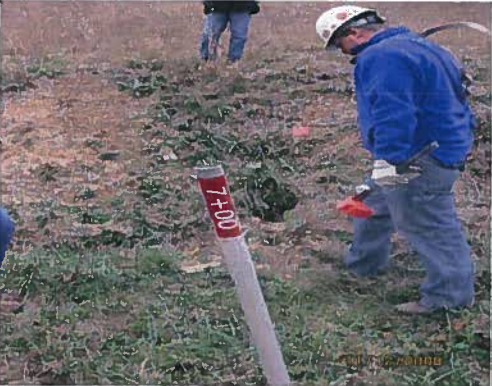
| I - Storage Pond - North Dike - (Road to Recreational Area) | | Storage Pond Elev. 778.1' |
|--|---|---|
| a. Condition | Grass covered - Overall - Grass has been cut. Localized bare spots noted on previous inspections have been re-seeded & straw placed over seed. Grass starting to grow in some places. (On-going maintenance issue). Rodent hole at Sta. 7+00 (photo 3), localized fire ant mounds. All flagged for repair by plant personnel. | 2, 3 |

| Photo No. | Description | |
|---|---|--|
| 3 | Storage Pond - East Dike - Localized rodent holes to be filled in and fire ant mounds to be treated. The rodent holes and fire ant mounds were flagged by plant personnel | |

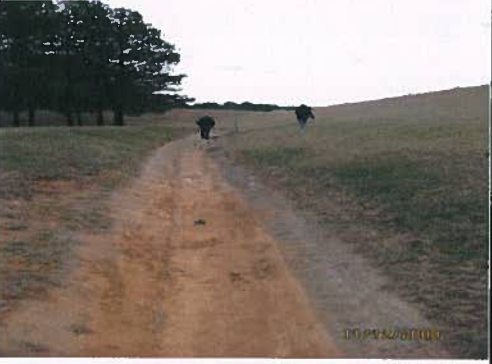
| Photo No. | Description | |
|---|---|--|
| 4 | Storage Pond - East Dike - Ditches cleaned out of debris/silt | |

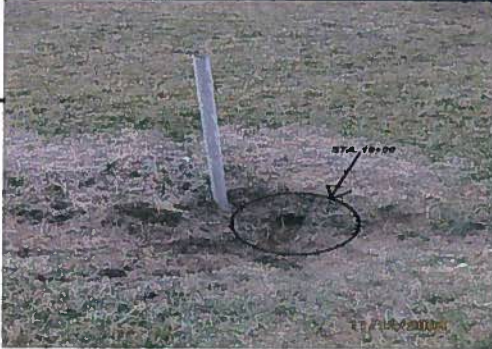
| I - Storage Pond - North Dike - (Road to Recreational Area) | | Storage Pond Elev. 778.1' |
|--|---|---|
| d. Concrete-Lined Drainage Ditch | Concrete in good condition. Localized vegetation growth and debris has been removed from ditches (photo 4). Good job done. Drain pipes at Sta. 19+00 and 22+00 need to be cleaned out and repaired (photos 4 and 5) | 4, 5 & 6 |

| Photo No. | Description | |
|---|--|--|
| 5 | Storage Pond - East Dike - Drain pipe at Station 19+00 needs to be cleaned out. Drain needs to be extended to prevent future clogging | |

| No. | Location and Description | Photo No. |
|---|---|---|
| 2 | Storage Pond - Downstream Slopes - Sta 19+00 & 22+00 and 37+50D - Drain pipes need to be cleaned out and repaired. Undermined concrete ditch to be repaired (per Hydro Services 5-28-08 letter) | 5, 6, 14 & 15 |

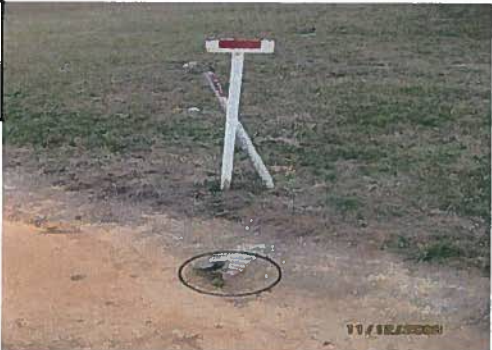
| Photo No. | Description | |
|---|--|--|
| 6 | Storage Pond - East Dike - Drain pipe at Station 22+00 needs to be fixed. Crushed end to be replaced/repaired | |

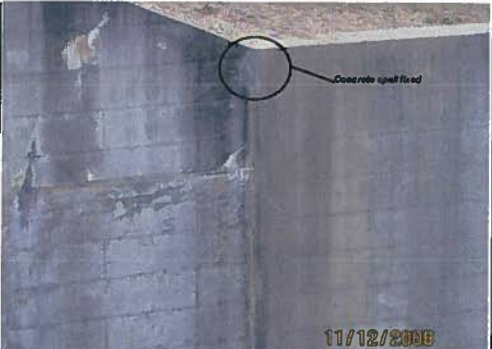
| I - Storage Pond - North Dike - (Road to Recreational Area) | | Storage Pond Elev. 778.1' |
|--|---|---|
| a. Condition | Concrete condition is satisfactory. Per Ga SDP letter 4-3-08, spall at left abutment has been repaired. | 7 |

| Photo No. | Description | |
|---|--|--|
| 7 | Storage Pond - Spillway - Concrete spill on downstream wall has been fixed. | |

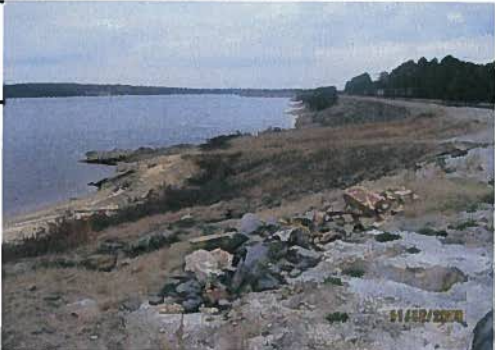
| Photo No. | Description | |
|---|--|--|
| 8 | Storage Pond - Southeast Dike - Upstream - Bushes and trees have been removed at toe of slope. | |

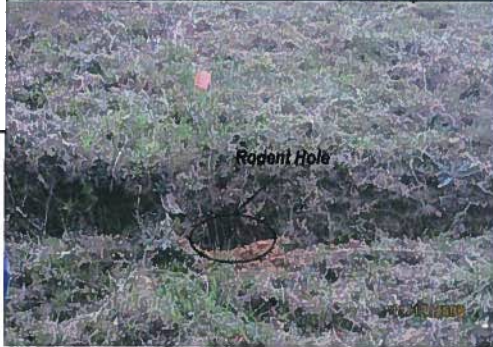
| Photo No. | Description | |
|---|--|--|
| 13 | Storage Pond - Southeast Dike - Downstream-Lower Slope at Sta 37+ 50. Rodent hole to be repaired. Flagged by field personnel. | |

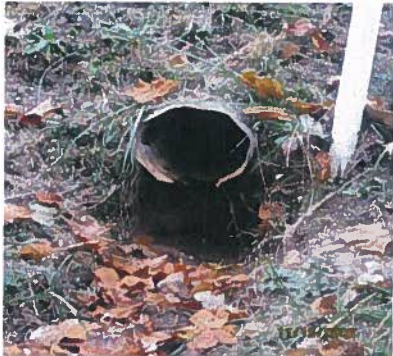
| Photo No. | Description | |
|---|--|--|
| 14 | Storage Pond - Southeast Dike - Downstream-Lower Slope at Sta 37+ 50 Drain D - Undermining at end of concrete drainage pipe requires repair. | |

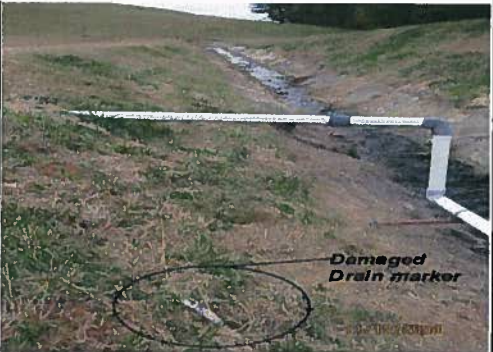
| Photo No. | Description | |
|---|--|--|
| 16 | Storage Pond - Southeast Dike - Downstream - Lower Slope at Sta 56+00 - Damaged drain marker to be replaced | |

| No. | Location and Description | Photo No. |
|---|---|---|
| 5 | Storage Pond - Downstream Slope - approx. Sta 56+00 - Damaged marker pole for toe drain needs to be repaired. | 16 |

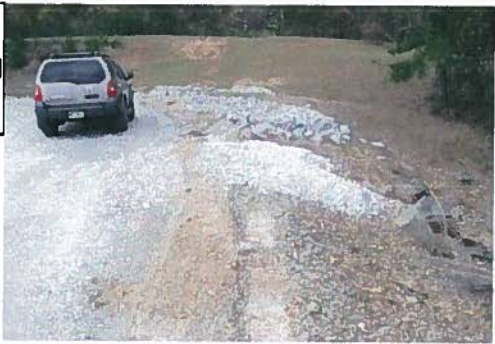
| Photo No. | Description | |
|---|--|--|
| 19 | Storage Pond - Spearator Dike- Upstream and Downstream - Erosion gullies have been repaired with stone/rip-rap | |

| No. | Location, Description & Action | Status Open/Closed |
|---|---|---|
| 9 | Separator Dike - Upstream & Downstream Slopes - Localized erosion rills/gullies need to be repaired to mitigate further erosion. - Fixed | Closed |

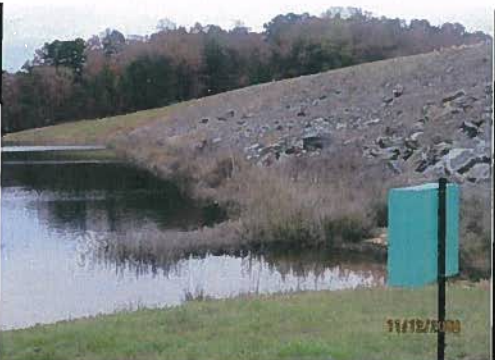
| Photo No. | Description | |
|---|--|--|
| 20 | Potable Water Pond- Upstream Slope - Small trees and bushes have been cut down at downstream toe. | |

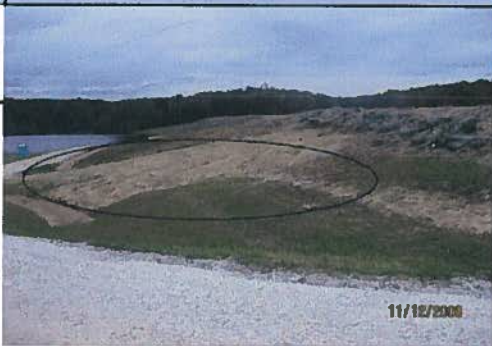
| Photo No. | Description | |
|---|---|---|
| 21 | Potable Water Pond- Upstream Slope - Localized bare areas have been re-seeded and grass is starting to grow. | A photograph showing a grassy slope next to a body of water. A circular area of re-seeded grass is highlighted with a black circle. The date 11/12/2008 is visible in the bottom right corner. |

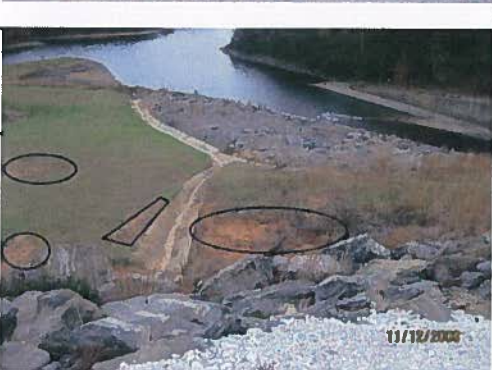
| Photo No. | Description | |
|---|---|---|
| 22 | Potable Water Pond- Downstream Slope - Localized bare areas need to re-seeded and grass reestablished | A photograph showing a downstream slope with several localized bare areas highlighted by black circles and a rectangle. The date 11/12/2008 is visible in the bottom right corner. |

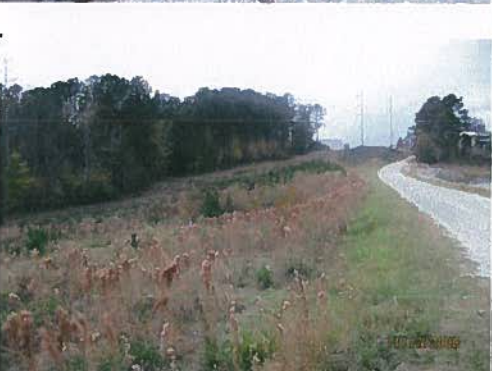
| Photo No. | Description | |
|---|---|---|
| 23 | Detention Pond - Downstream Slope. Small trees to be removed. Grass and weeds to be cut. | A photograph showing a downstream slope with tall grass and weeds. The date 11/12/2008 is visible in the bottom right corner. |

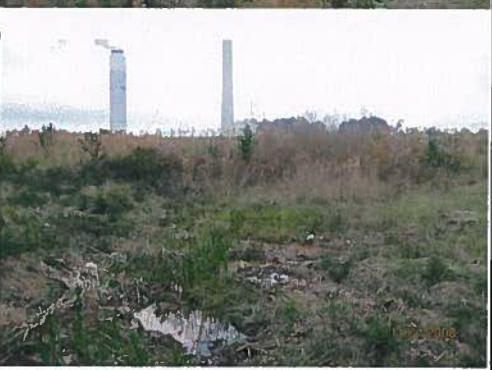
| Photo No. | Description | |
|---|---|---|
| 24 | Detention Pond- Downstream - Localized wet areas downstream of toe of slope. Need to investigate source of water. Plant to coordinate with Hydro Services. | A photograph showing a downstream slope with wet areas. In the background, industrial structures are visible. The date 11/12/2008 is visible in the bottom right corner. |

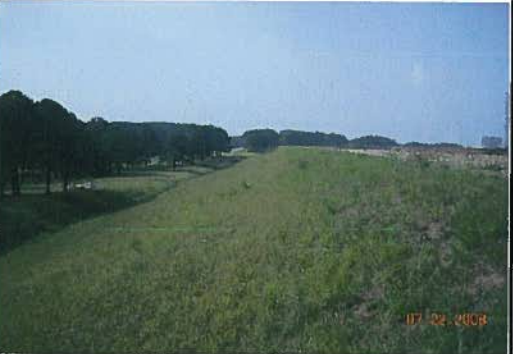
| I - Storage Pond - North Dike - (Road to Recreational Area) | | Storage Pond Elev. 783.6' |
|--|---|---|
| a. Condition | Grass covered - Overall - looks good. Grass cutting in progress. Localized bare spots need to be re-seeded & mulched (photo 6 - Sta 11+20) | 3 & 6 |

| Photo No. | Description | |
|---|---|--|
| 3 | Storage Pond - E. Dike - Downstream slope in good condition | |

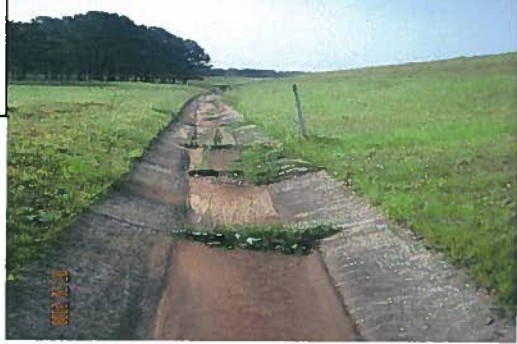
| I - Storage Pond - North Dike - (Road to Recreational Area) | | Storage Pond Elev. 783.6' |
|--|---|---|
| d. Concrete-Lined Drainage Ditch | Concrete in good condition. Localized vegetation growth and debris needs to be removed from ditches so that flow isn't restricted from approx. Sta. 1+60 to 3+50 and Sta. 5+00 to 23+50. | 4 & 5 |

| Photo No. | Description | |
|---|--|--|
| 5 | Storage Pond - East Dike - Concrete lined toe ditches - Vegetation/Debris needs to be cleaned out of ditch (Approx Sta. 5+00 to 23+50) | |

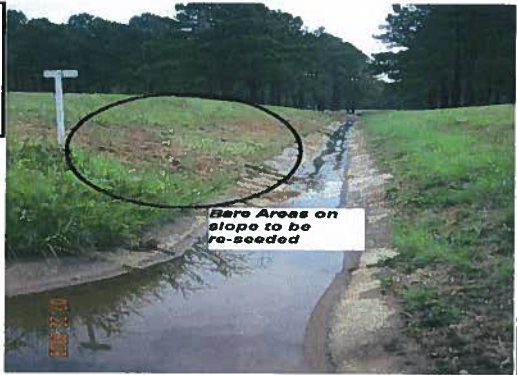
| Photo No. | Description | |
|---|--|--|
| 6 | 'Storage Pond - East Dike - Bare spots on slope to be re-seeded to prevent further erosion. Sta 11+20 | |

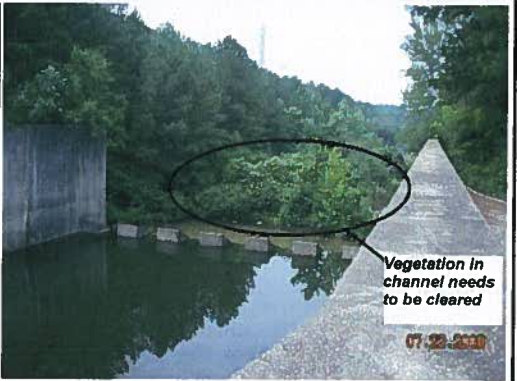
| I - Storage Pond - North Dike - (Road to Recreational Area) | | Storage Pond Elev. 783.6' |
|--|---|---|
| a. Condition | Vegetation downstream of spillway needs to be cleared to prevent blockage/restriction of flow capacity of channel | 8 |

| Photo No. | Description | |
|---|--|--|
| 8 | Storage Pond -Spillway - Vegetation downstream of end of spillway needs to be cleared. | |

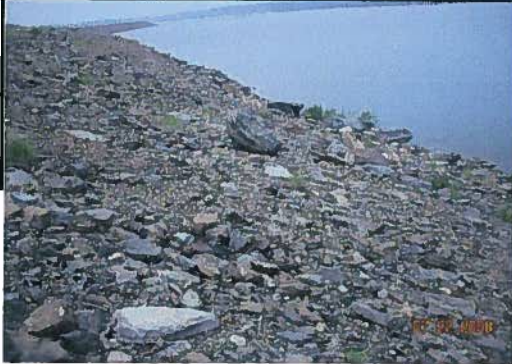
| IV - Storage Pond - Southeast Dike (Spillway to Separator Dike) | | |
|---|---|---|
| a. Condition | Rip-rap (size varies) on upstream slope looks acceptable. No instability or beaching evident. (SCG to assess condition per GA EPD-SDP letter 4/3/08). Bushes and trees at toe of slope need to be cut down to prevent potential instability issues at toe of slope (see Photo 10) | 9, 10 |

| Photo No. | Description | |
|---|---|--|
| 9 | Storage Pond - Southeast Dike - Upstream Slope - Rip-rap varies in size from gravel size to 18"-24", occasional 24" to 36" nominal size. Per GA Safe Dams letter of 4-3-08, this will be addressed by SCG Hydro Services. | |

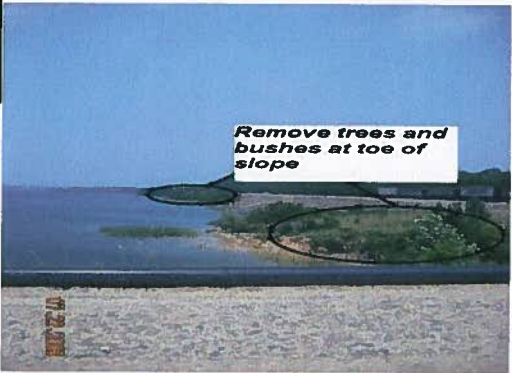
| Photo No. | Description | |
|---|---|--|
| 10 | Storage Pond - Southeast Dike - South end near Separator Dike. Bushes and trees need to be removed at toe of slope. | |

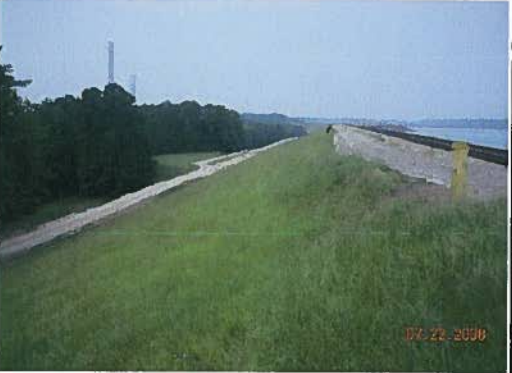
| IV - Storage Pond - Southeast Dike (Spillway to Separator Dike) | | |
|---|---|---|
| a. Condition | Grass covered - looks satisfactory. No evidence of instability observed. | 11 |

| Photo No. | Description | |
|---|---|--|
| 11 | Storage Pond - Southeast Dike - Downstream (D/S) - Upper Slope looks satisfactory | |

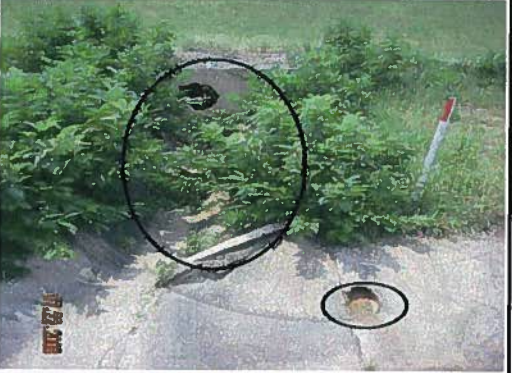
| IV - Storage Pond - Southeast Dike (Spillway to Separator Dike) | | |
|---|---|---|
| b. Concrete-Lined Drainage Ditch | Concrete in good condition. Vegetation in ditch/around drain at Sta. 73+00 needs to be removed so that flow isn't restricted. Localized areas where grass growing and silt has built up on bottom of drainage ditch. Removal of vegetation and silt required | 12 |

| Photo No. | Description | |
|---|---|--|
| 12 | Storage Pond - Southeast Dike- D/S -Silt and debris removal required at outlet of Drain at Sta. 73+00 and 74+00 | |

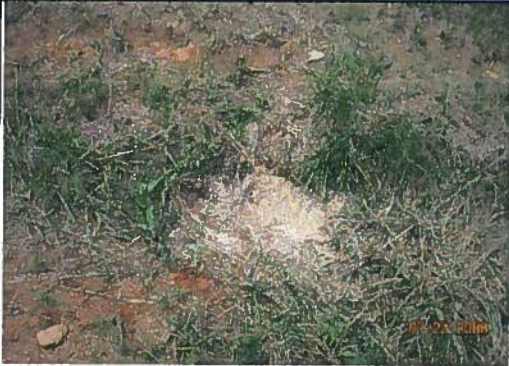
| IV - Storage Pond - Southeast Dike (Spillway to Separator Dike) | | |
|---|---|---|
| a. Condition | Grass covered. Satisfactory. No visual evidence of instability. Previous rodent hole filled in. | 13 |

| Photo No. | Description | |
|---|---|--|
| 13 | Storage Pond - Southeast Dike D/S - Previous rodent hole has been filled in. | |

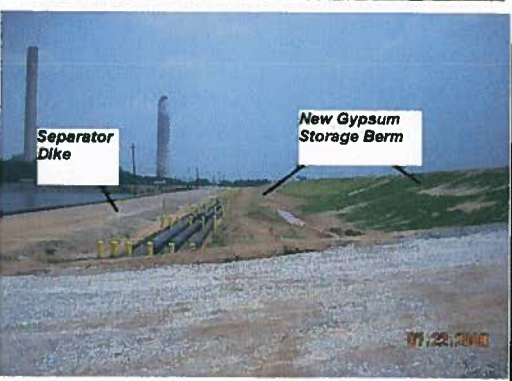
| V - Storage Pond/Ash Pond - Separator Dike | | Pond Elev. 783.6' |
|--|---|--|
| a. Condition | N/A - Recently constructed gypsum storage pond dike now abuts the south end of the separator dike. | 19 |

| Photo No. | Description | |
|--|---|--|
| 19 | Storage/Ash Pond - Separator Dike - South End. Gypsum Storage pond berm on right side of photo. | |

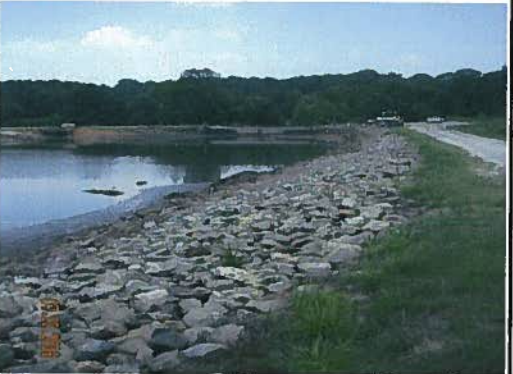
| Photo No. | Description | |
|---|---|--|
| 23 | Detention Pond - Upstream Slope - Rip-rap in good condition, no visible evidence of instability. | |

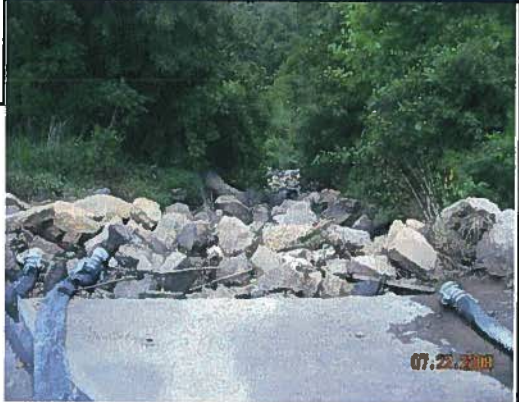
| Photo No. | Description | |
|---|---|--|
| 25 | Detention Pond - Outfall Channel - Rip-rap and channel are in good condition. No erosion or instability observed. | |

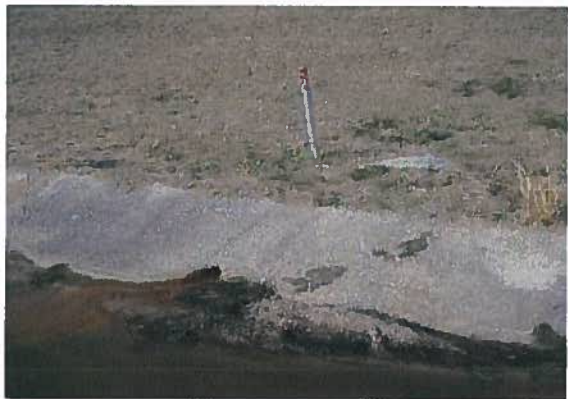
Pt. 131 – Sta. 77+00 – Localized build-up of grass, silt and debris. **Requires clean out of the outlet end of the finger drain.**

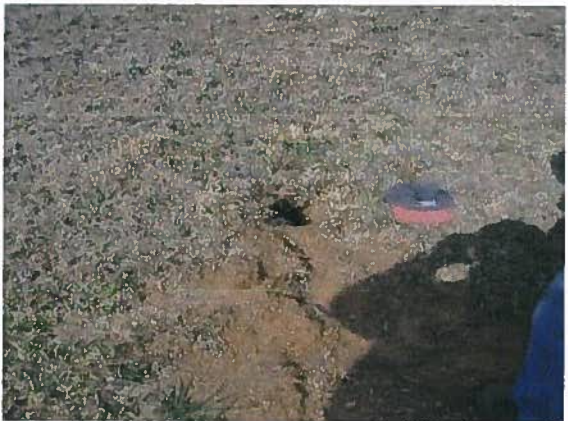
Sta. 76+60 – **Animal Burrow** needs to be filled in.

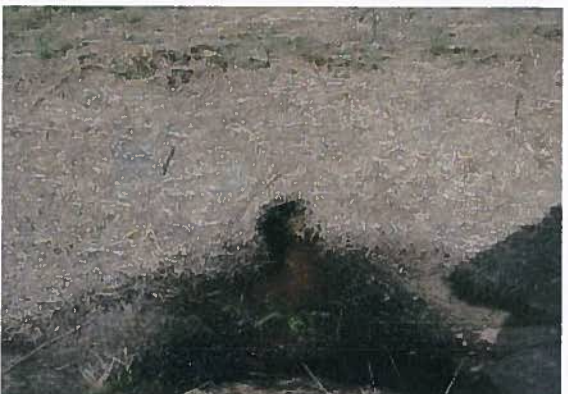
Pt. 132 – Sta. 76+00 - Localized build-up of grass, silt and debris. **Requires clean out of the outlet end of the finger drain.**

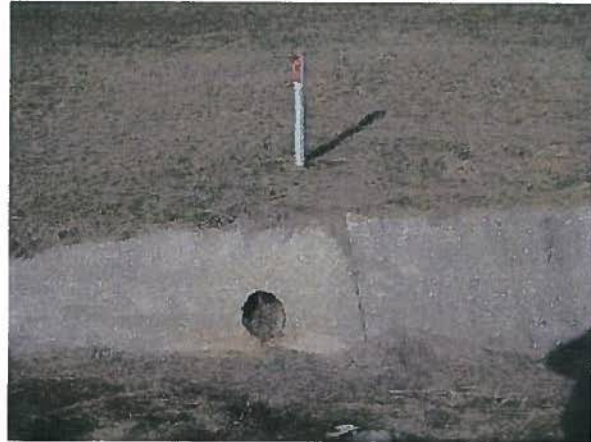
Sta. 75+00 – Localized build-up of grass, silt and debris. **Requires clean out of the outlet end of the toe drain.**

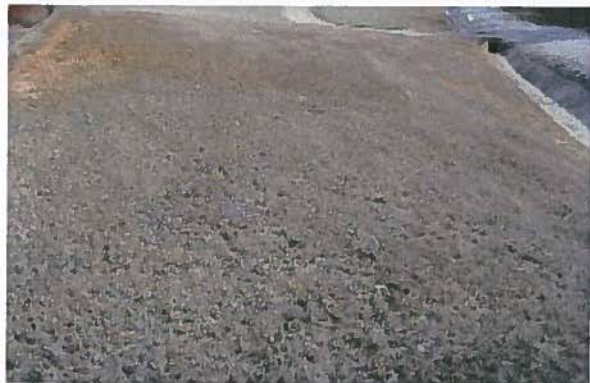
Sta. 73+00 to 74+00 – Bare spots on slope. **Re-seed and mulch areas to re-establish grass cover to mitigate surface erosion.**

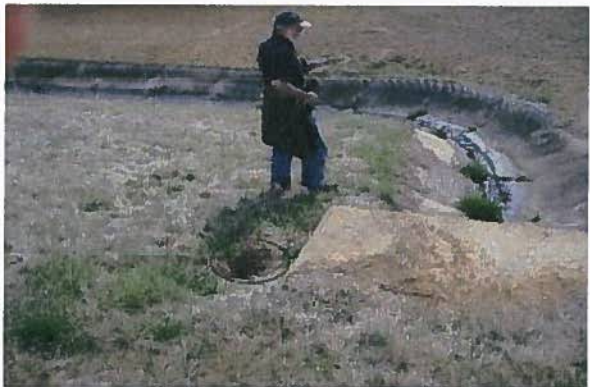
Pt. 133 (Approx. 75+50)
Pt. 134 (Sta. 73+00)
Pt. 135, 136 (pictured at right) and 137
(~Sta 66+67)

Animal burrows need to be filled in.
